# ADVERSE HIGH RAIL PROFILES: IDENTIFICATION, RISKS AND A SOLUTION

FRA Track Safety Symposium  
St. Louis, MO  
April 6, 2022

*Brad Kerchof*  
*Advanced Rail Management*  
*Norfolk Southern Railway (retired)*

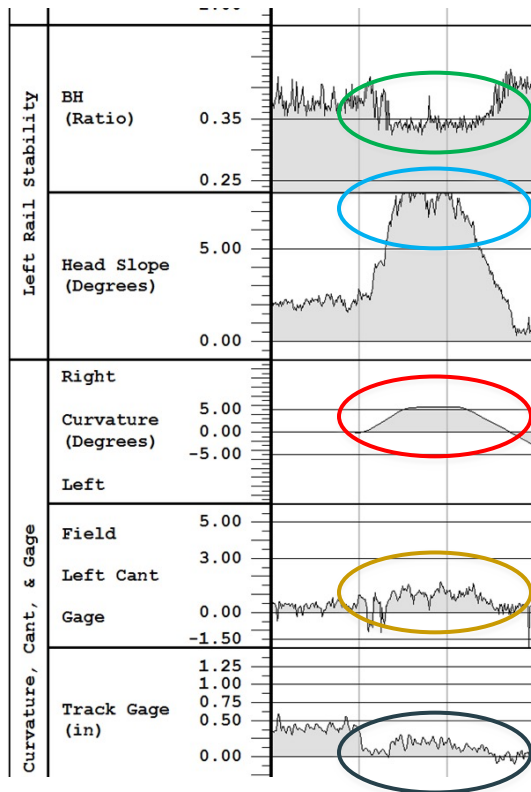
➤ B/H 0.34

➤ Head slope  $8^{\circ}$

➤ Curvature  $5^{\circ}$

➤ Rail cant  $1^{\circ}$

➤ Gage  $\frac{1}{4}''$ , or  $56\text{-}3/4''$

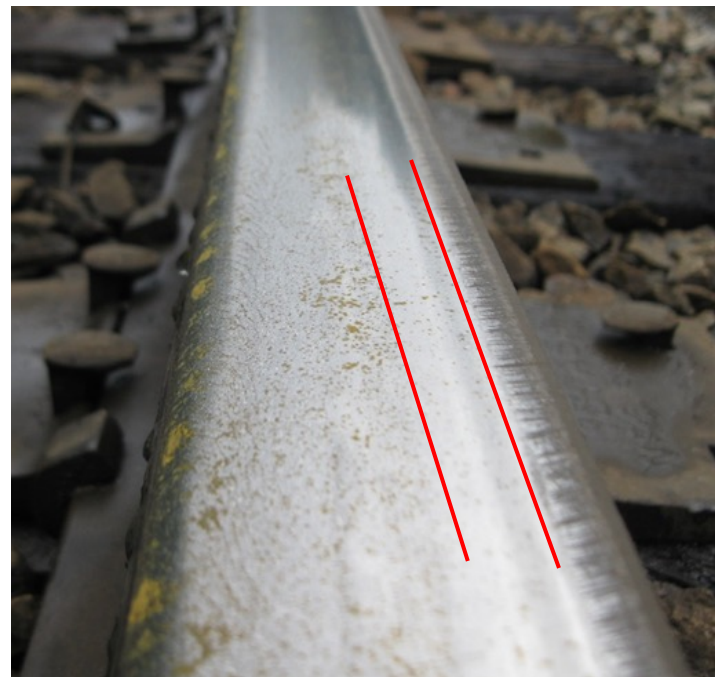
NS rail wear graph

Primary contact band is on field side

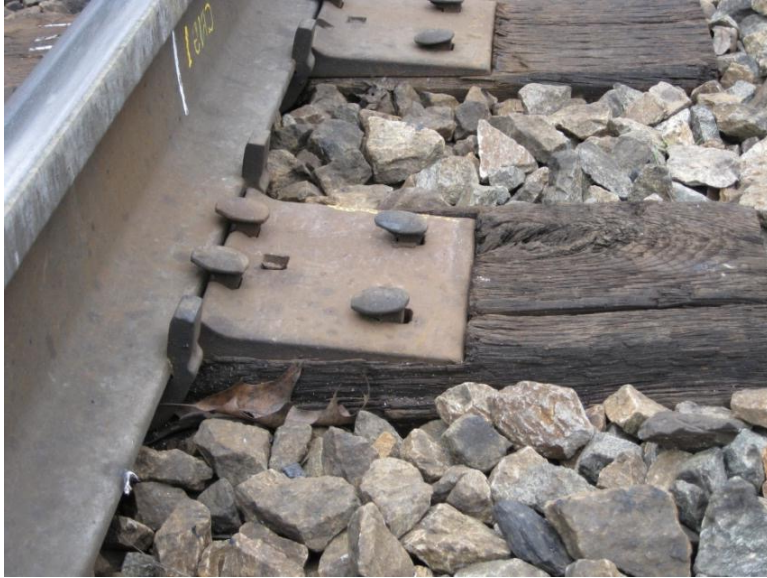
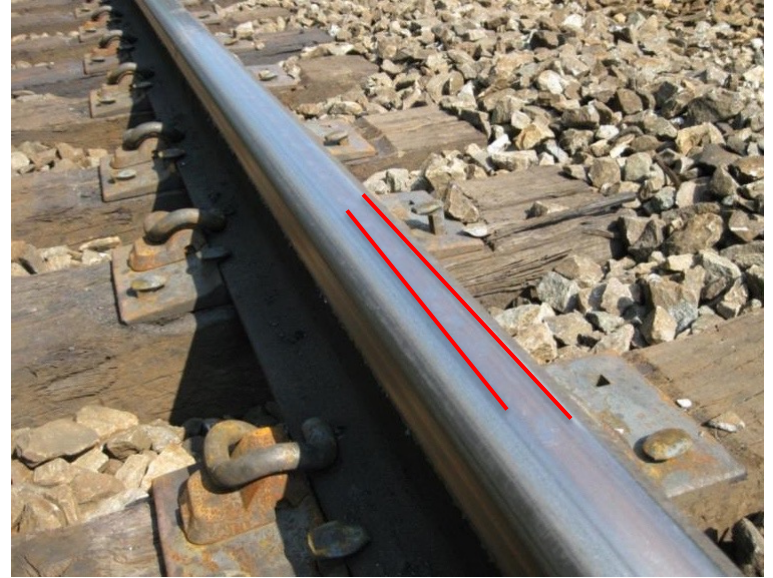
- The high rail, which had 3° of outward cant because of plate cutting, had the cant removed when the ties were adzed during gaging & fastener replacement.
- The primary wheel contact band shifted toward the field side.

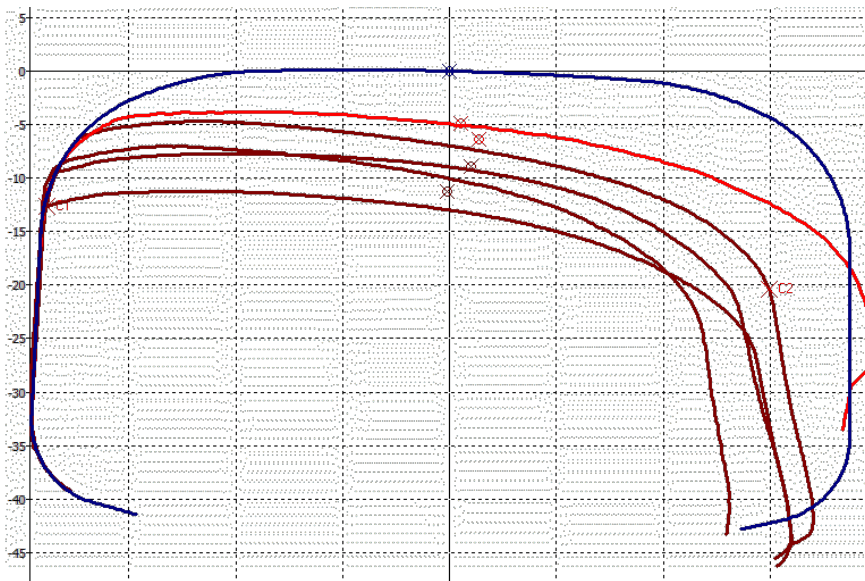
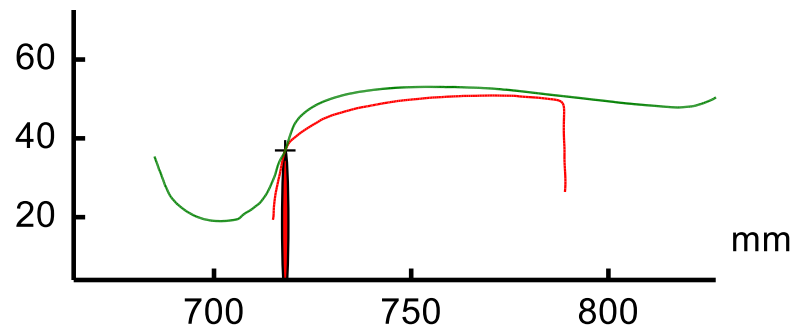
High rail profiles from five NS rail roll-over derailments (aligned on field side with a new 136RE profile, 1:40 inward cant)

Adverse contact produced by curve-worn rail and 3.5mm hollow-worn wheel.  
Example of extreme 2-point contact.

Hollow-worn treads are more likely to make field-side contact.

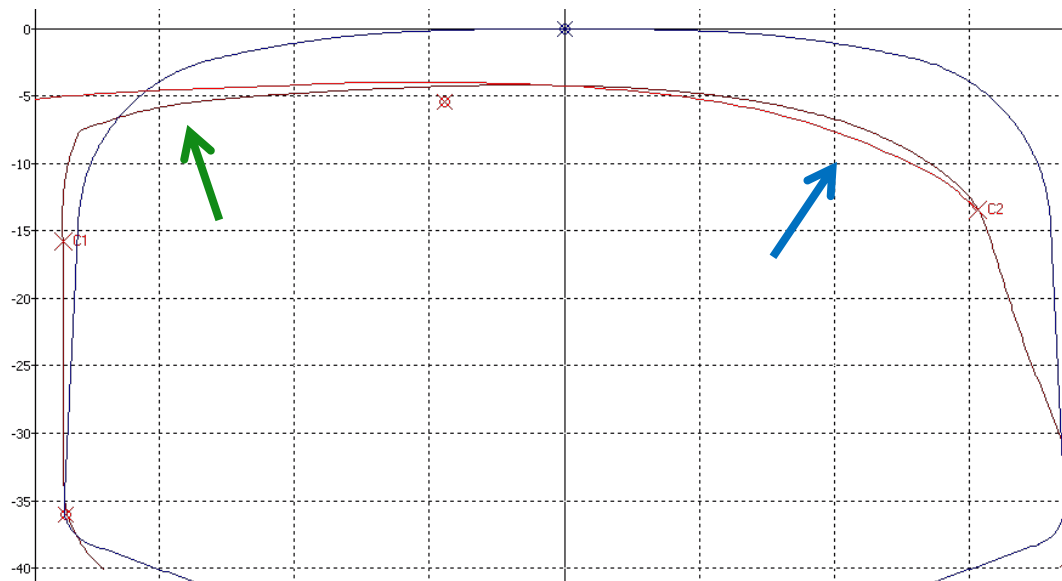
Brown profile: a curve-worn high rail with 3° outward cant

Red profile: high rail template used by Loram & NS

The template can be moved laterally & vertically, but it cannot be rotated

Significant grinding on the gage side  
but no grinding on the field side

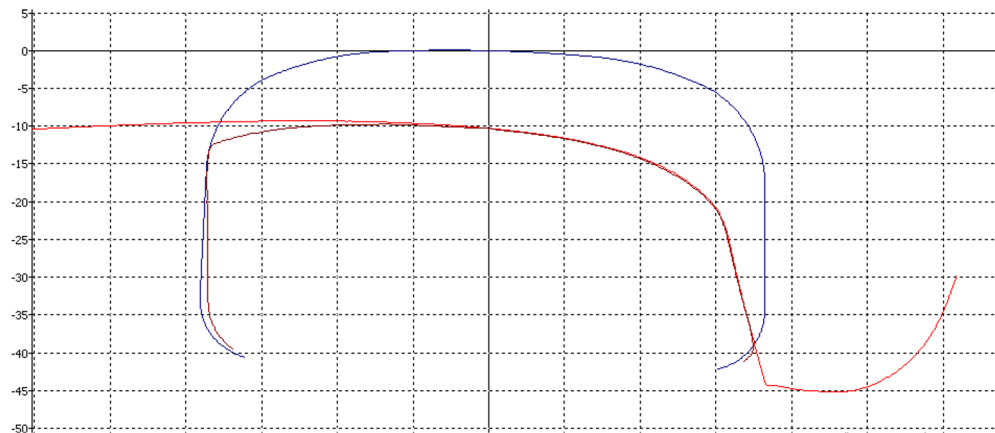
Above: A slightly-worn wheel on curve-worn rail with 3° cant

This is conformal contact, which produces favorable wheelset steering

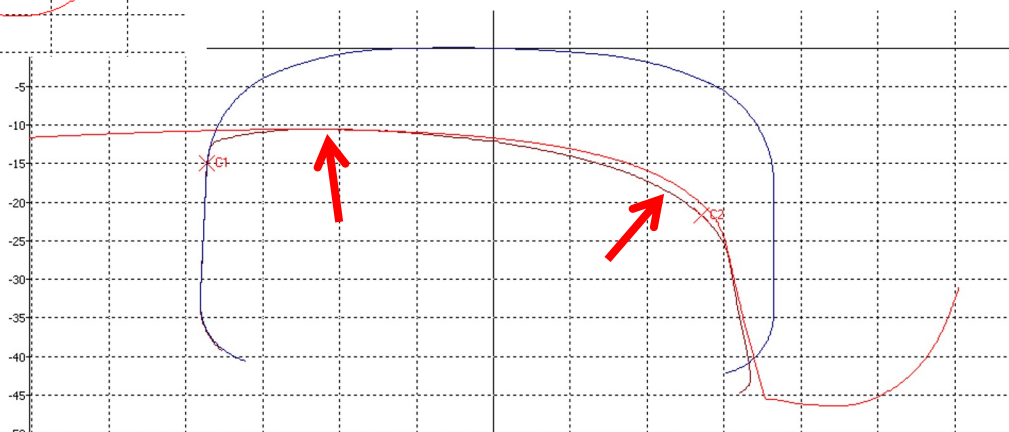
Below: The same slightly-worn wheel and curve-worn rail, but the rail has been set up to 0° cant.

Result: Wheel tread contact has moved toward field side. This is two-point contact, which produces higher-resistance curving and increased lateral force.

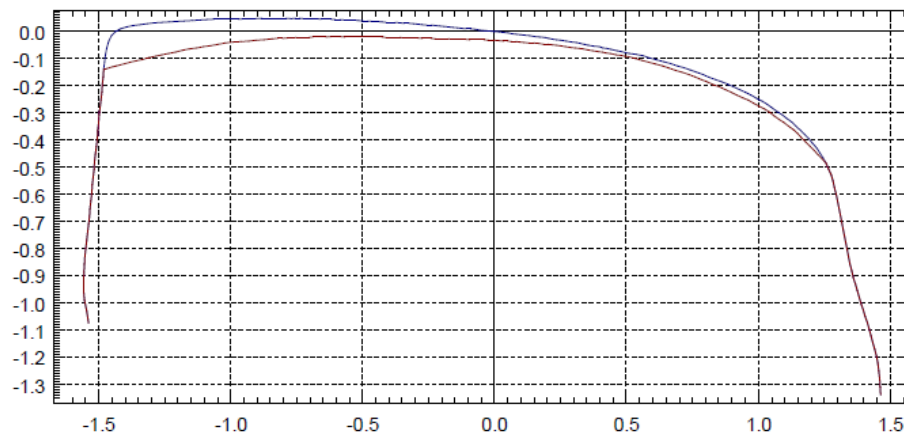
High rail of a 6° curve. The blue profile is pre-grind, and the brown profile is post-grind. A full 1/8-inch was ground off the field-side corner. Both profiles have been rotated to 0° cant.

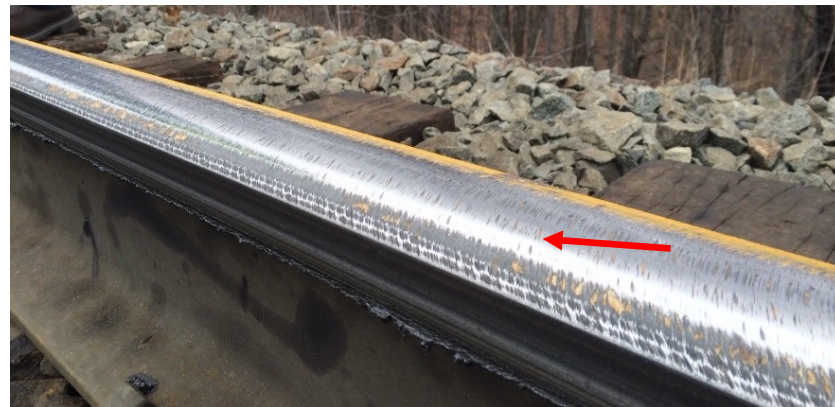
The same high rail several days after grinding. The primary wheel contact band was moved toward the gage side. Enough metal was removed from the field side to maintain gage-side wheel contact even after the rail was gaged.

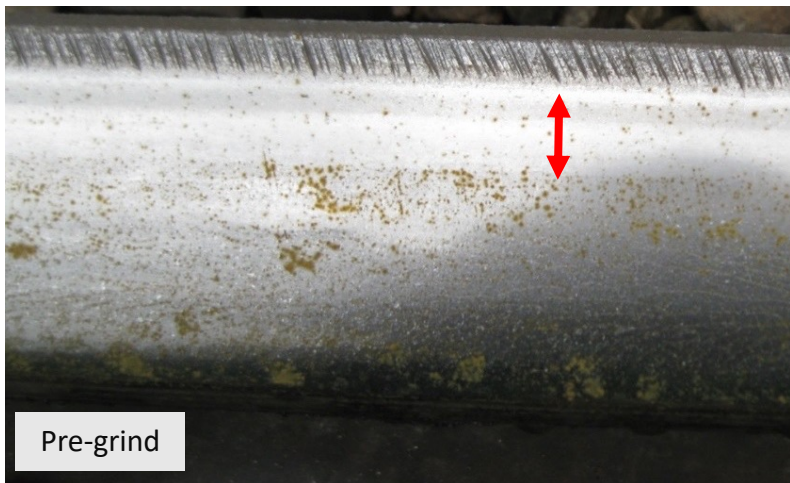
Pre-grind

**Pre-grind:** Primary contact band is on the field side  
Side wear 6/16", cant 1.5°, B/H 0.34, head slope 8°

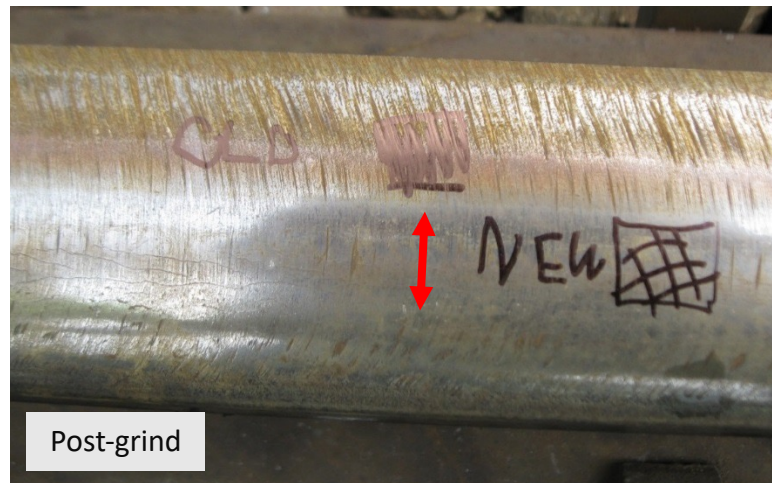
Post-grind

**Post grind:** Wheel contact shifted toward gage side

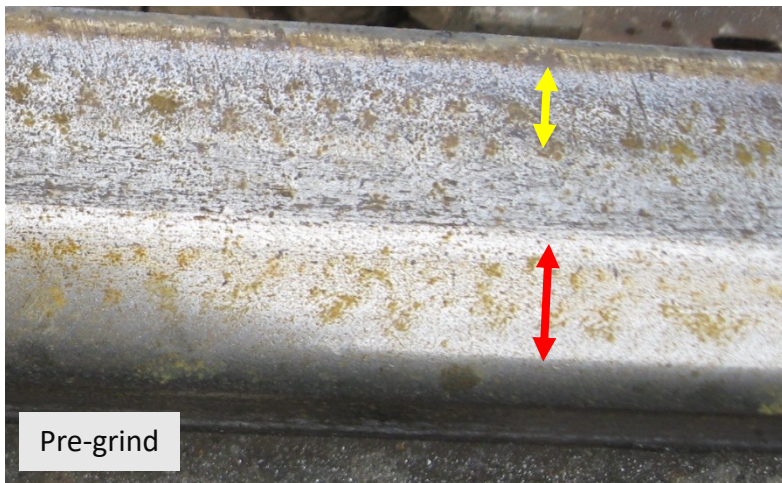
Pre-grind

**Pre-grind:** Primary contact appears to be on gage side (red arrow). There is some field-side wheel contact (yellow arrow), though still-visible grinding marks suggest wheel frequency is low.

Side wear 6/16", cant 1°, B/H 0.35, head slope 6°.

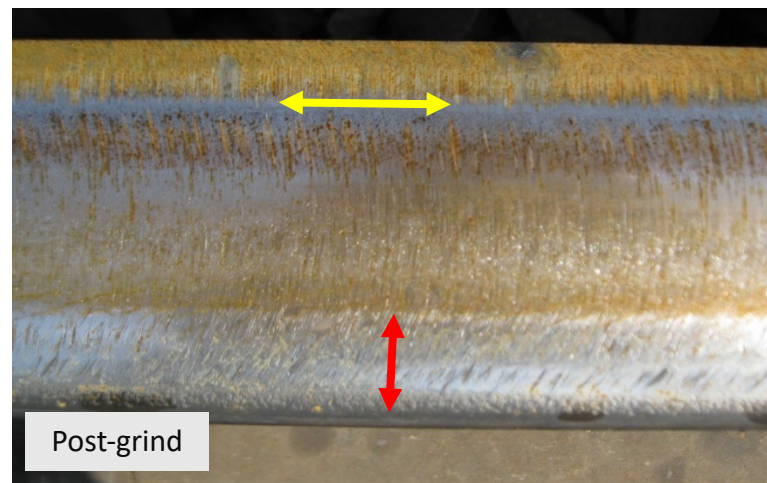
Post-grind

**Post grind:** After 3 passes, the primary wheel contact band is more concentrated on the gage corner (red arrow).

Field-side contact by hollow-tread wheels is still apparent (yellow arrow).

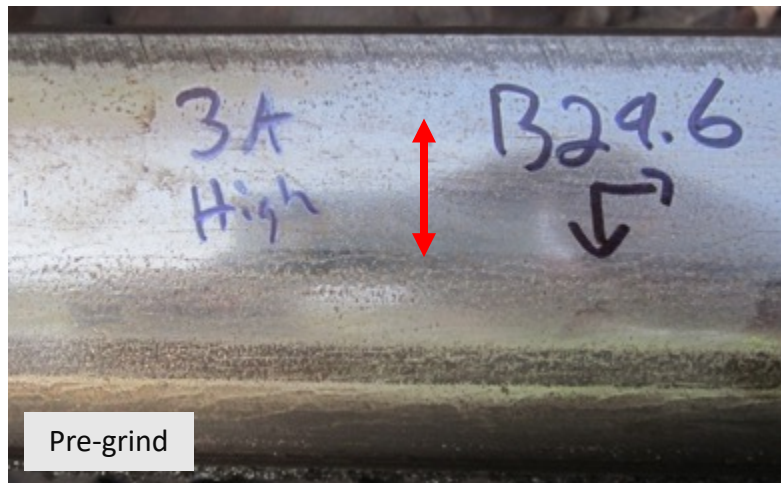
Pre-grind

**Pre-grind:** Primary wheel contact is at the center, though there is evidence of wheel contact over most of the head

Side wear 7/16", cant 0°, B/H 0.35, head slope 8°

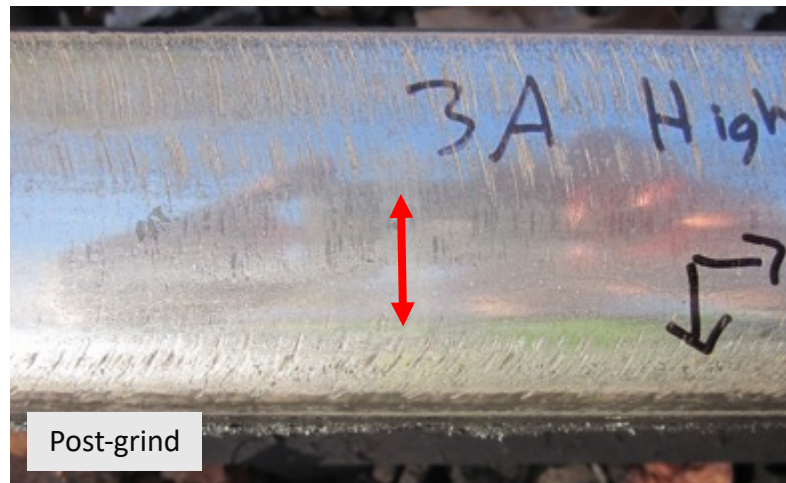
Post-grind

**Post-grind:** Primary wheel contact has shifted toward the gage side

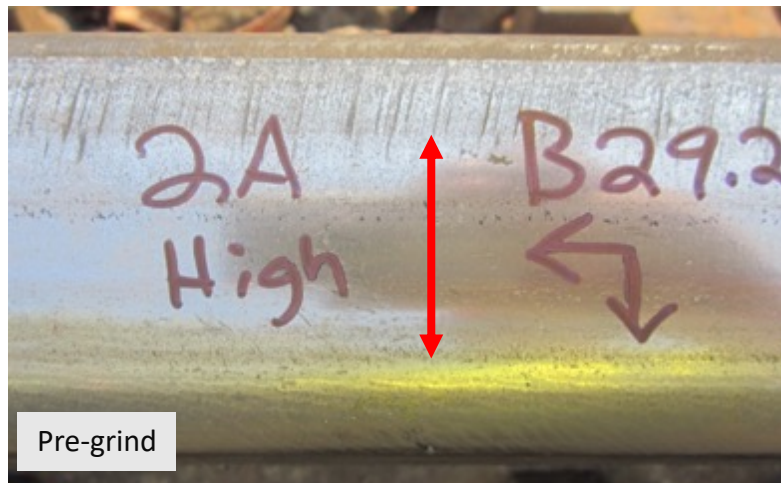
**Pre-grind:** Primary wheel contact is at the center, though there is significant wheel contact over most of the head

Side wear 7/16", cant 0°, B/H 0.35, head slope 8°

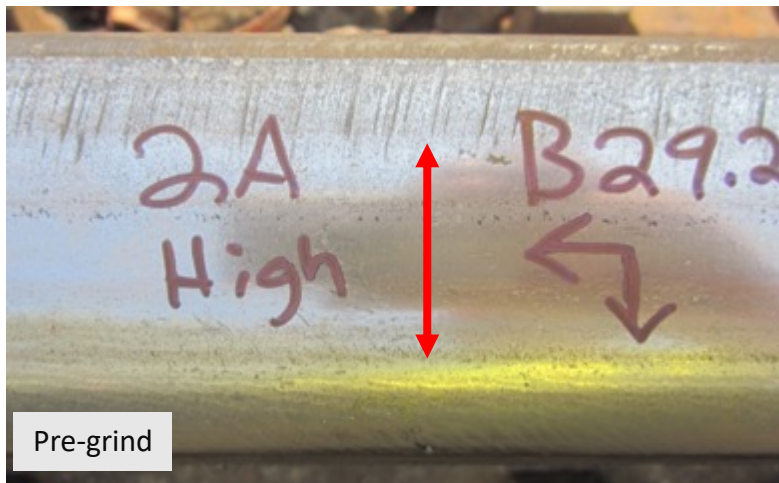
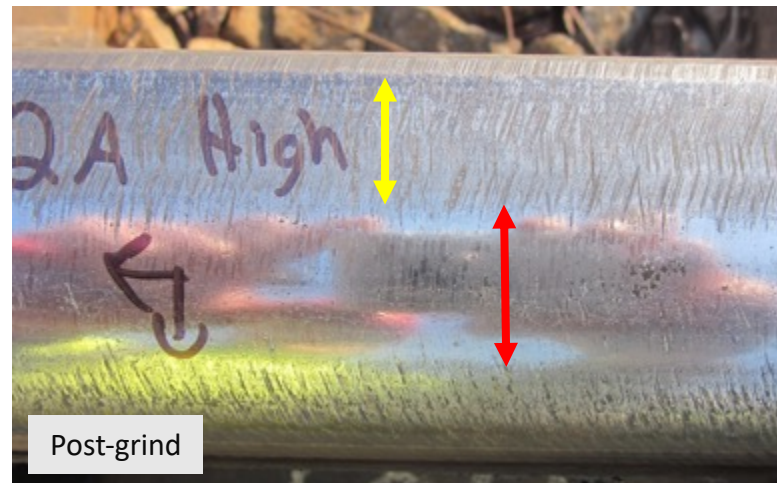
**Post-grind:** Primary wheel contact has shifted to the gage side of center. Some hollow-tread wheel contact is still evident on the field half of the head (yellow arrow).
